Clinton County Engineer's Office

Melvin Road and Stone Road Intersection

Safety Report

Report: November 24, 2025

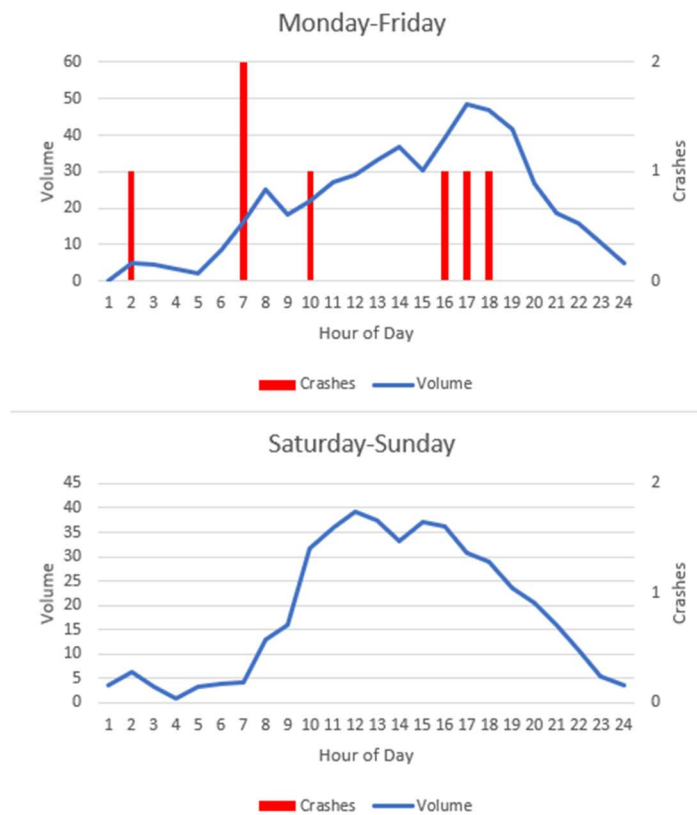
Figure 1 – Crash Distribution by time of day

Since 2016 there have been seven recorded crashes in the intersection of Stone Road and Melvin Road. Of those seven crashes, four of them resulted in injuries. All of the incidents within the intersection were caused by vehicles on Stone Road either failing to yield (three crashes) or failing to stop (four crashes). **Table 1** along with **figure 1** shows a breakdown of the crash data. A diagram of the crash history can be seen in **figure 2**.

Crashes look to be focused around the morning and afternoon peaks of the day during the weekdays. This could be correlated to the increased industrial traffic that this intersection sees Monday through Friday and peaks around those times.

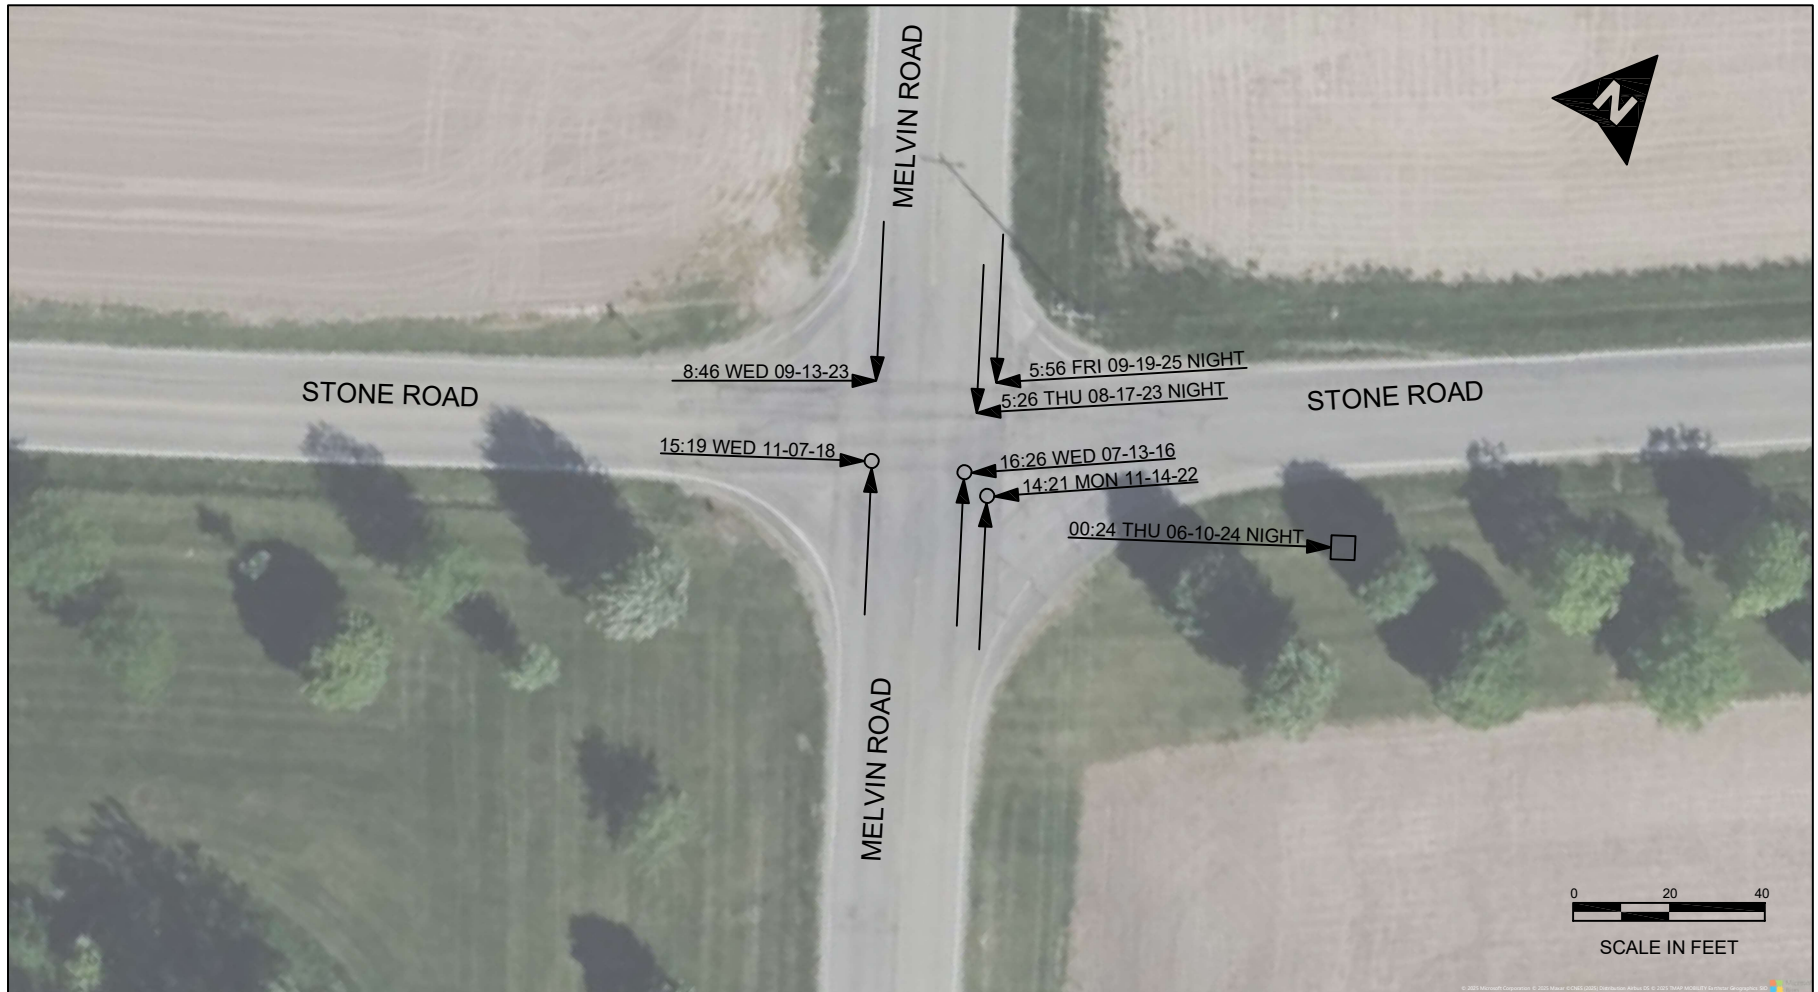
FIGURE 1

CRASH TOTALS

- 3 PROPERTY DAMAGE ONLY
- 4 INJURY
- 7 TOTAL CRASHES

NOTES:
 -CRASH TEXT IS ORIENTATED WITH THE AT FAULT VEHICLE
 -CRASH DATA FROM 2016-2025

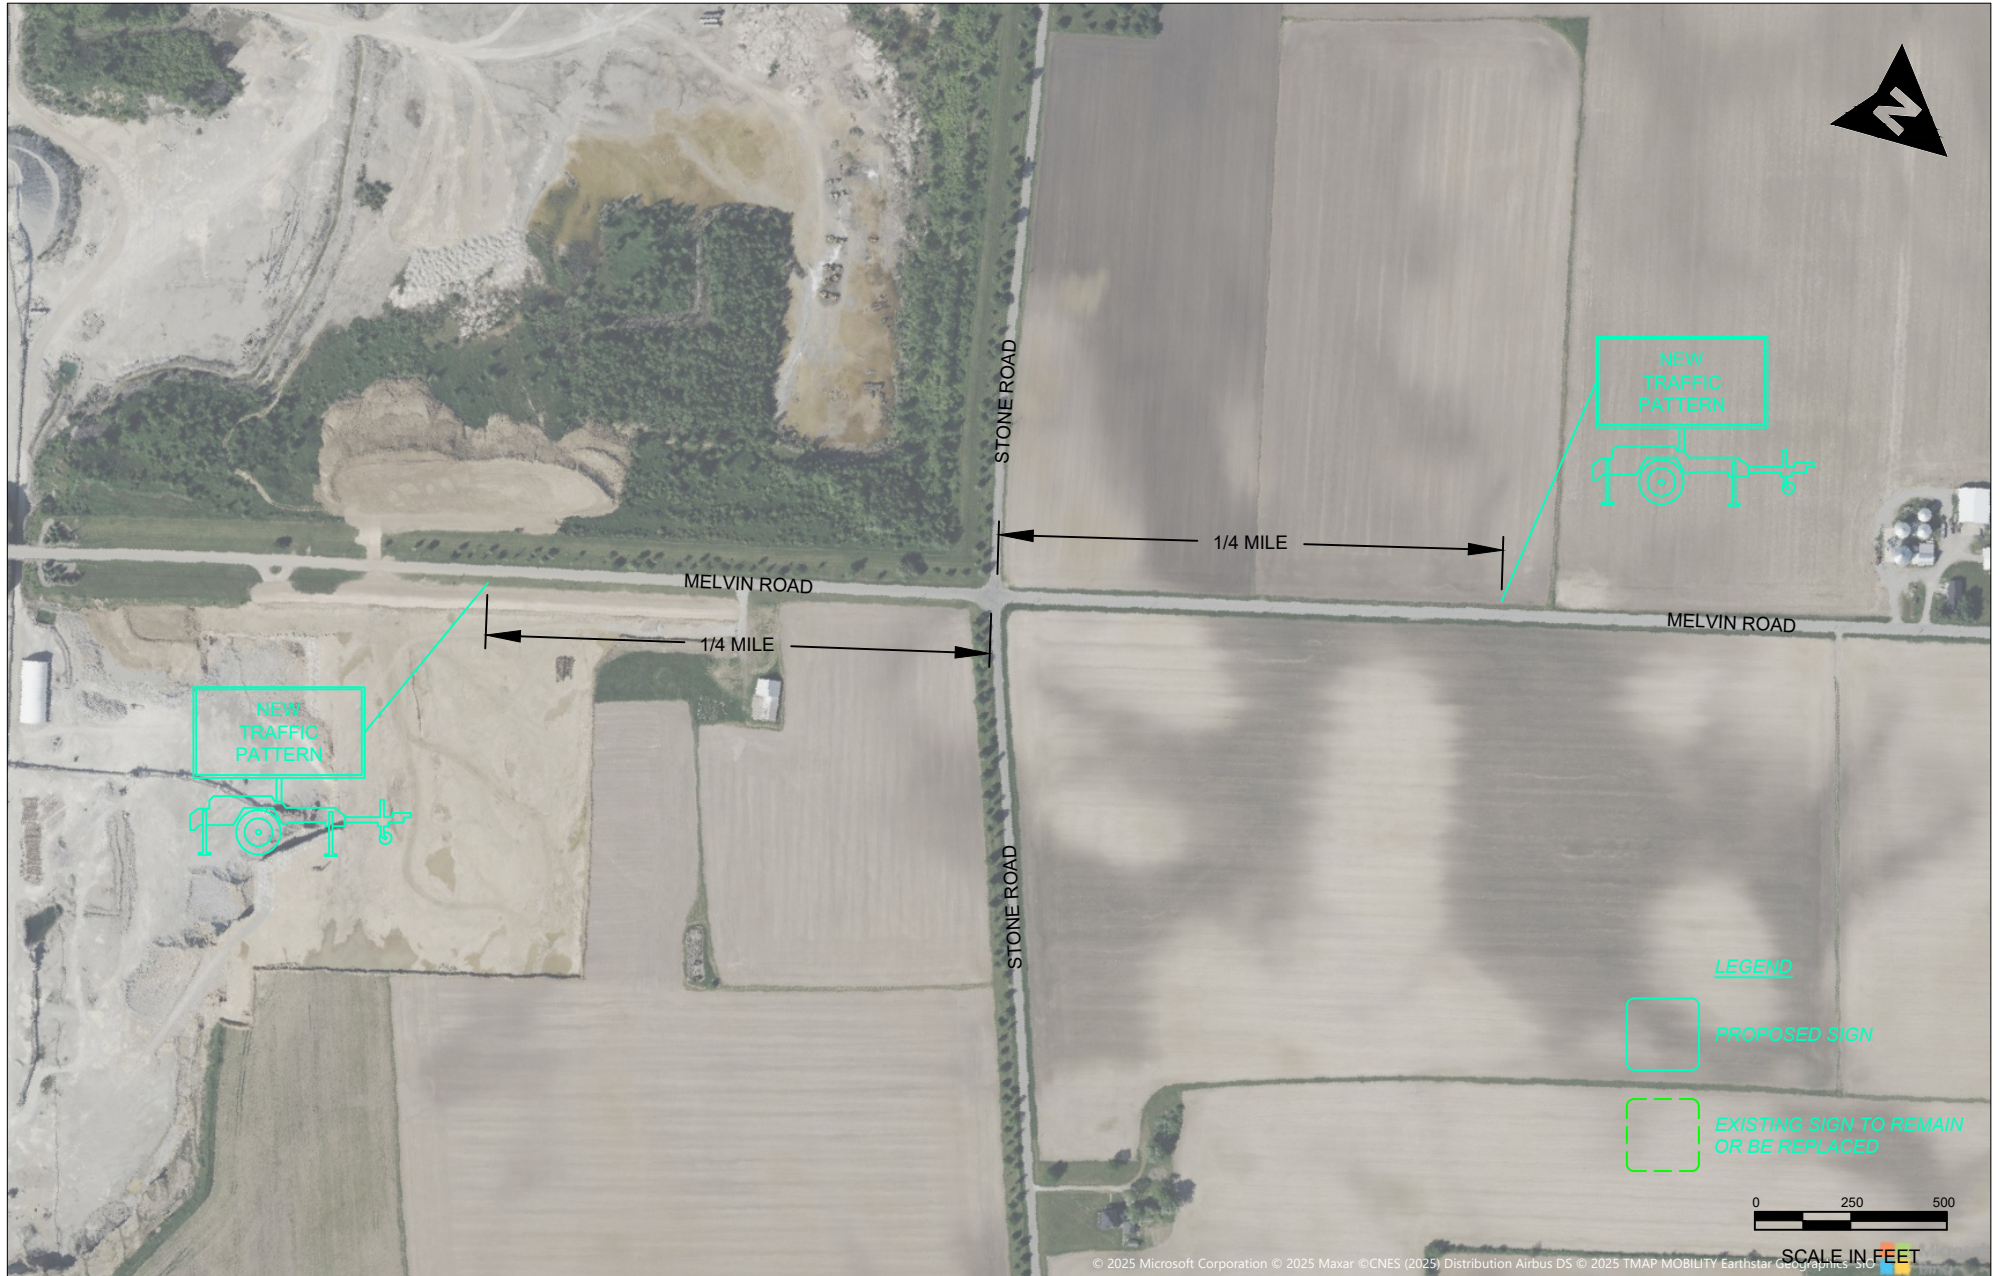
FIGURE 4

It is recommended that an all-way stop is a viable solution to reduce the types of crashes seen at this intersection. Figure 3 shows the proposed signage recommended for the intersection while figure 4 shows the proposed temporary signage to be used during implementation.
